## **Pultruded FRP Plank as Formwork and Reinforcement for Concrete Structures**

University of Wisconsin, Madison, WI

A feasibility study in which a pultruded fiber reinforced polymer (FRP) plank was used as the both formwork and the tensile reinforcement for a concrete structural member is described in this paper. The study was motivated by the desire to use the FRP plank as a stay-in-place form and reinforcement for a new bridge that is currently being designed in Wisconsin and will be constructed in early 2007. For the FRP plank and the concrete to act as a “composite” structural member a satisfactory bond at the interface between the smooth surface of the pultruded plank and the concrete must be developed. To achieve this interface, stone aggregates of different sizes were bonded to the surface of the pultruded FRP plank. Two kinds of aggregate, gravel and sand, were bonded to the pultruded FRP plank using a commercially available epoxy system. Concrete beams of different lengths were fabricated using a commercially available pultruded FRP plank. No additional flexural or shear reinforcement was provided in the beams. Two of the beams were used as control specimens. One contr

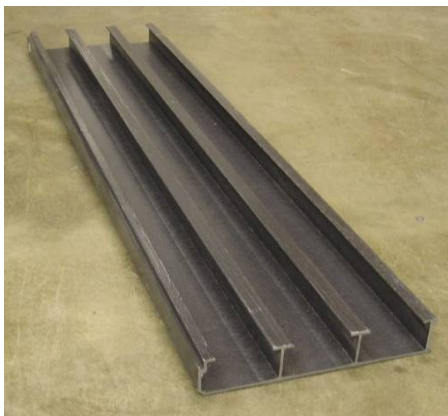
**Figure-1a** 12 inch wide pultruded FRP plank

In this study, an inverted portion of a commercially available FRP plank having integral T-shaped ribs, shown in Fig. 1a, was used as the formwork and the reinforcement for the concrete. The FRP plank is produced in 12 and 24 inch widths and is used in walkway or flooring applications with the flat side facing up and has a smooth inner surface. (Silica sand grit is often applied to the flat surface of the plank to create a non-slip walking surface). Two types of stone aggregate, sand and gravel, were bonded to the inner flat surface of the plank to improve the bond between the concrete and the FRP plank. The aggregate was bonded with epoxy to the FRP plank, which was cured, prior to the placement of the concrete. The feasibility of using this system was investigated experimentally using beams of different lengths that were tested in three point bending. The test results from the FRP plank specimens were compared to code predictions and to the results obtained from the control specimens.

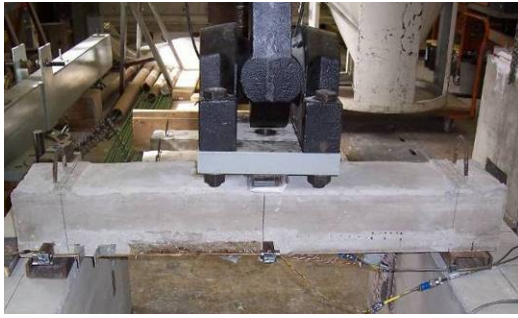
**Figure-5** Experiment setup of specimen 1 prior to loading

The load was applied at the center of the specimen in a three point bend test configuration by a hydraulic actuator under manual displacement control. A 3 inch wide steel plate was placed at the bottom of the loading head. Gypsum cement was cast between the loaded top surface of the specimen and the steel plate to transfer load uniformly along the center line of the specimen. Figs. 5 and 6 show the test setup for the specimens 1 and 4, respectively.

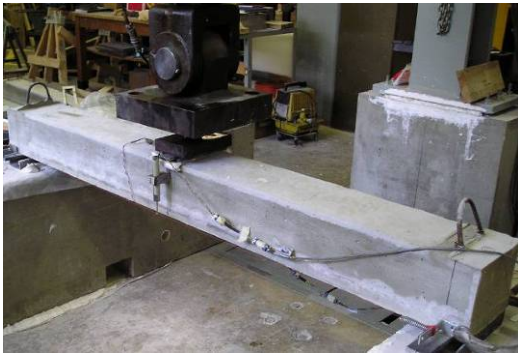
**Figure-6** Experiment setup of specimen 4 prior to loading

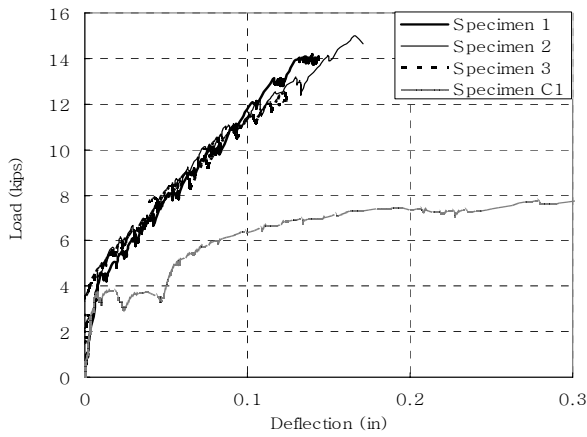
**Figure-9 Load-deflection plots for specimens 1-3 and C1**

additional load and a secondary peak was seen. This secondary peak seemed to be due to the tensile force provided by the FRP plank that was trapped under the supports, or may have been due to residual friction. The specimen was felt to have lost its composite action at the first load peak due to the previously noted significant slip. The first peak load was, therefore, selected as an ultimate capacity of this specimen. The load deflection curves of the 3' 7" beams are shown in Fig. 9.

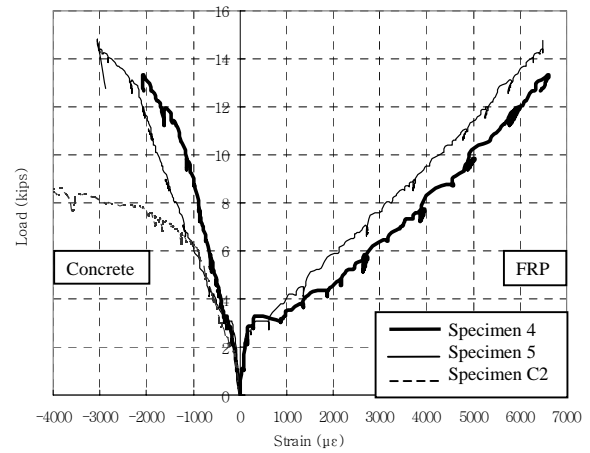
**Figure-12 Load-strain plots for specimens 4-5 and C2**

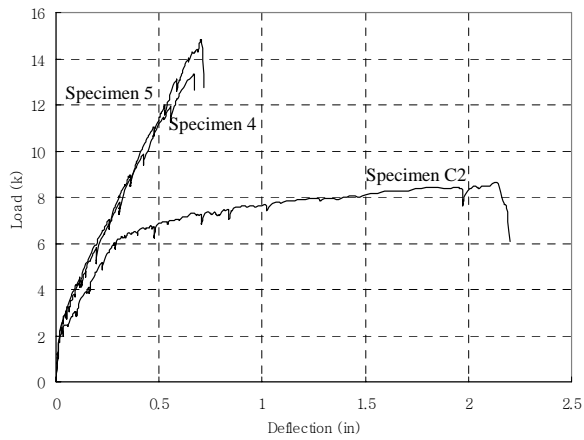
**Figure-10 Load-deflection plots for specimens 4-5 and C2**

Specimens 4-5 failed in a hybrid mode of shear and flexure at the failure load, after the occurrence of distributed flexural cracking. This failure mode was felt to have occurred since a significant diagonally crack developed simultaneously with visible concrete crushing near the loaded area, as seen in Figs. 8 (a) & (b). This can also be classified as a shear-compression failure. At failure the compressive strain level at the top surface of the concrete reached 0.003 which is generally accepted to the failure strain of concrete in compression. The control specimen (specimen C2) for specimens 4-5 failed in a flexural mode with yielding of steel reinforcement followed by crushing of concrete which is the typical failure mode of an under-reinforced steel reinforced beam, as seen in Fig. 8 (c). The ultimate capacity for the specimen C2 was 58~64% of specimens 4 and 5 and demonstrates that the aggregate coated FRP plank can be used as tensile reinforcement instead of the steel reinforcement for a beam designed to achieve the capacity of the steel reinforced beam. As can be seen from the load-deflection plot in Fig. 10 the deflection at failure in the steel reinforced beam is much larger than that of the FRP plank reinforced beam. However, the load at failure in the FRP plank beam is larger than that of the steel beam. This is a common situation in over-reinforced FRP beams (ACI, 2006).

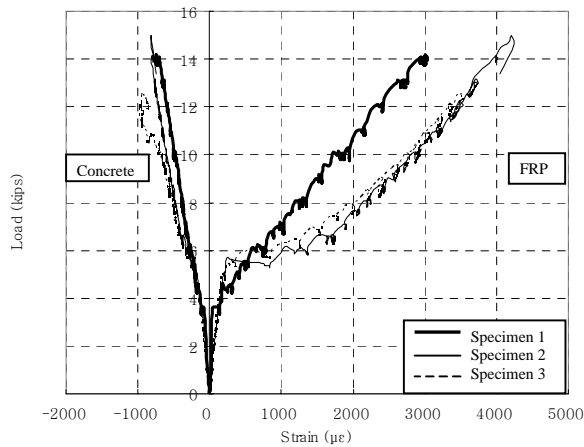
**Figure-11 Load-strain plots for specimens 1-3**
