## Hybrid Pultruded Plank with a Concrete Compression Flange for Pedestrian Bridges

Bryan V. Bindrich

Department of Civil and Environmental Engineering  
University of Wisconsin-Madison, WI

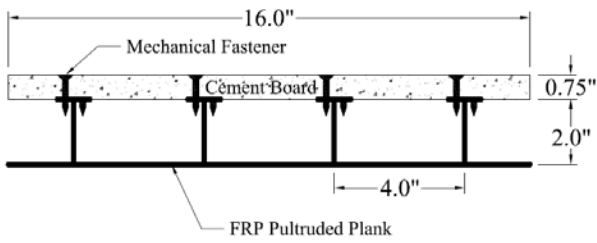
**Figure – 1. Dimensioned design drawing of cement board specimen with mechanical fasteners as the shear transfer mechanism.**

Five different hybrid specimens were fabricated for testing. Each specimen measured 72” x 16” x 2.75” with differences in materials and shear transfer mechanisms. Figures 1 and 2 display the design of the cement board specimen with mechanical fasteners as the shear transfer mechanism and the concrete specimen. In addition, Table 1 provides properties of each specimen and the labeling procedure.

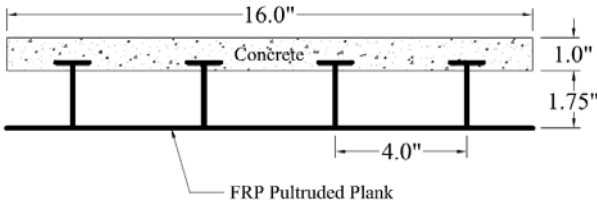
**Figure – 2. Dimensioned design drawing of concrete specimens.**

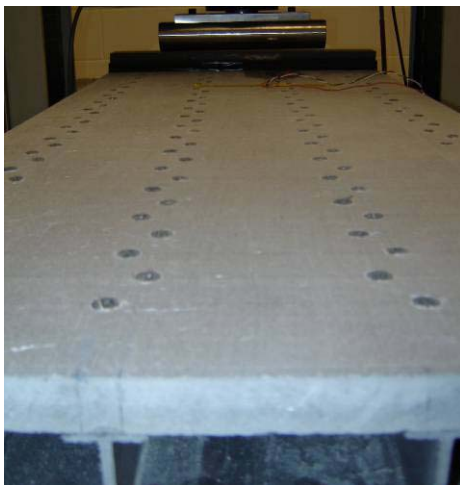
**Figure – 3. Mechanically fastened cement board specimen displaying fastener layout (Specimen 3).**

Specimen 2 and Specimen 3 were also composed of cement board and the FRP pultruded plank. In these specimens, the shear connection between the two specimens was made using mechanical fasteners, specifically sheet metal or dry wall screws. In Specimen 2, the intent was to achieve failure in the mechanical fasteners rather than the two base materials. The mechanical fasteners used were 1 ¼ inch long #6 self-drilling sheet metal screws. The fasteners were placed along each of the four flanges spaced at 3 inches along the span. Along each flange the screws were alternated from one side of the web to the other in order to evenly distribute the shear forces throughout the flange. Specimen 3 was designed in order to ensure failure in the cement board. In this specimen, 1 ¼ inch #9 cement board screws with varying thread sizes were spaced at 1 inch to achieve sufficient shear transfer between the cement board and pultruded plank. This design may not be practical for use, but the goal of this test was to achieve failure in one of the hybrid materials, specifically crushing of the cement board in the compression flange. Again, the location of the fastener on the flange was alternated in order to ensure an even force transfer throughout the flange and web (Figure 3). For both specimens, pre-drilling was performed. This method may not be necessary, but it was found easier to complete fabrication with pre-drilling in this study. Without pre-drilling, the mechanical fastener would have trouble penetrating the FRP plank flange.

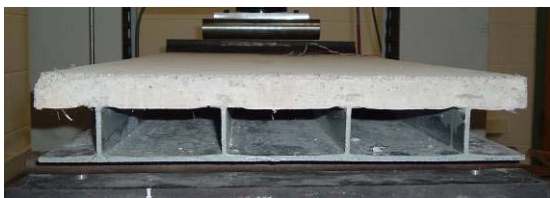
**Figure – 4. Concrete specimen displaying FRP flanges embedded in concrete (Specimen 4).**

Specimen 4 and Specimen 5 were composed of normal weight concrete and the FRP pultruded plank. Each specimen was composed of a 1" concrete compression flange with the FRP pultruded plank embedded ¼" into the concrete (Figure 4). Concrete cylinder tests found that the concrete had a compressive strength of 4,300 psi. The specimen was fabricated by first creating formwork for the concrete. Concrete was mixed and poured into the formwork (Figure 5). The FRP pultruded plank was then pushed into the concrete and a vibrator was used to help drive the plank into the concrete. Stops were placed on the formwork in order to ensure the plank achieved the correct depth. The flanges of the FRP plank embedded in the concrete were coated with wet epoxy to aid in increasing the bond strength between the concrete and FRP. No other surface treatment (such as sanding or aggregate grit surface coating) was performed on the flanges of the pultruded plank.

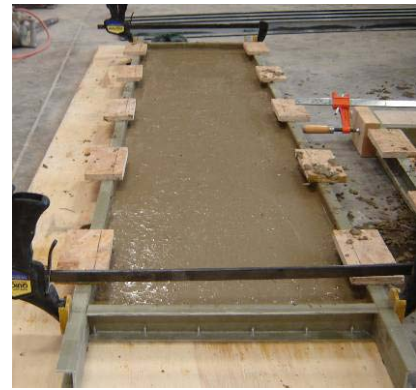
**Figure – 5. Formwork for concrete specimens with wet concrete prior to setting (Specimen 4).**

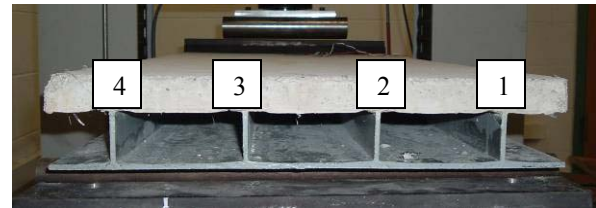
**Figure – 6. Web labels from north end of specimen (Specimen 4).**

For ease of description, a labeling procedure as seen in Figure 6 has been used. The flanges are labeled sequentially from 1 to 4 going from the west edge of the specimen to the east.

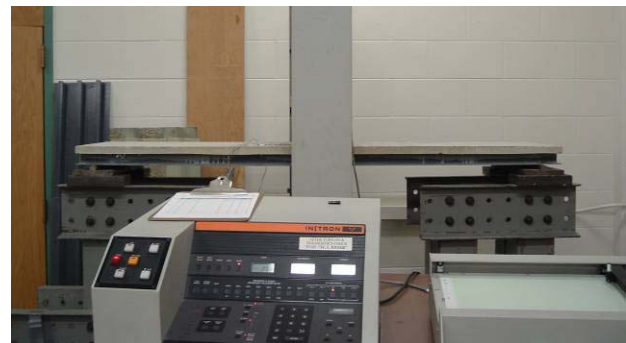
**Figure – 7. Experimental set-up (Specimen 4).**

The test set-up for the specimens is shown in Figure 7. The supports were steel rods placed in slotted steel plates which provided a simply-supported specimen allowing rotation at the ends. The center-to-center spacing of these rods was 66 inches.

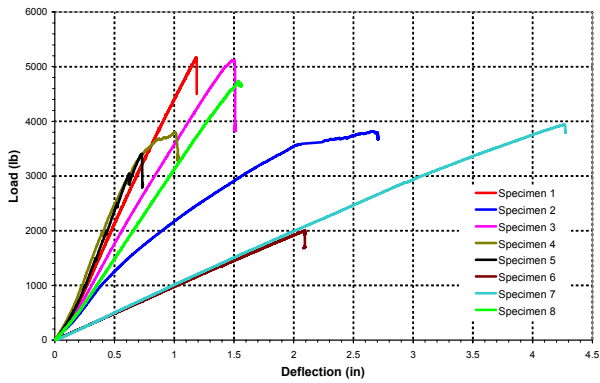
Figure – 9. Load vs. deflection graph for different specimens (Raw data).

Before any data could be analyzed, it was necessary to normalize the data in order to have consistent comparisons. For instance, all the specimens, except the timber specimen, had a width dimension of 16 inches. The timber specimen had a width dimension of 11 5/16 inches. Because of this difference in dimension, it was decided to normalize the load data to per foot of width. This provided a standard for which the data could be compared. The raw data load-deflection plots for all specimens can be seen in Figure 9 and the normalized load-deflection plots can be seen in Figure 10. Table 2 displays the failure loads and deflections for each specimen.

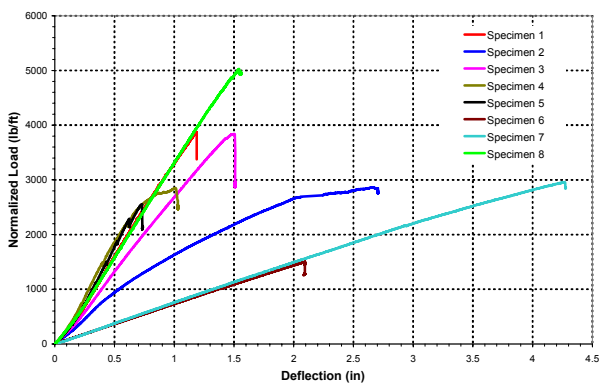
Figure – 10. Normalized load vs. deflection graph for different specimens.

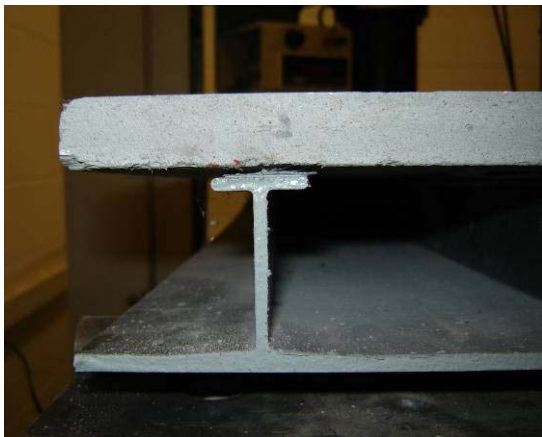
Figure – 11. Debonding failure in epoxy-bonded cement board specimen (Specimen 1).

Most failures for the specimens were seen at the interface between the cement board or concrete and FRP plank. Specimen 1 failed with a sudden debonding failure (Figure 11). The specimen reached a load of 5,180 lb and a deflection of 1.19 inches. This equates to a normalized load of 3,877 lb/ft width. Only the section of the specimen between the north support and load point failed in debonding; the remainder of the specimen stayed intact (Figure 12).

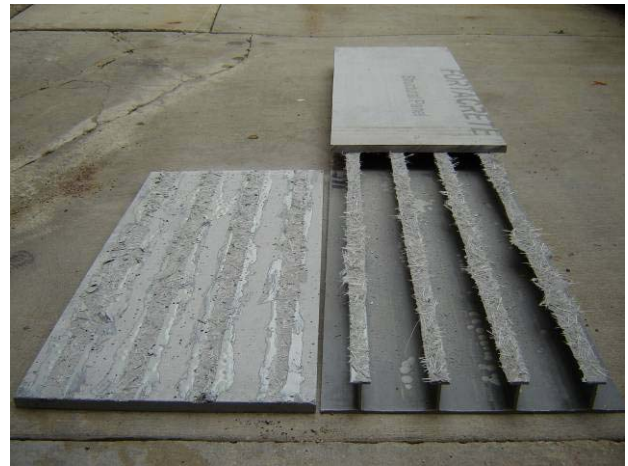
Figure – 12. Epoxy-bonded specimen cut to reveal debonding failure (Specimen 1).

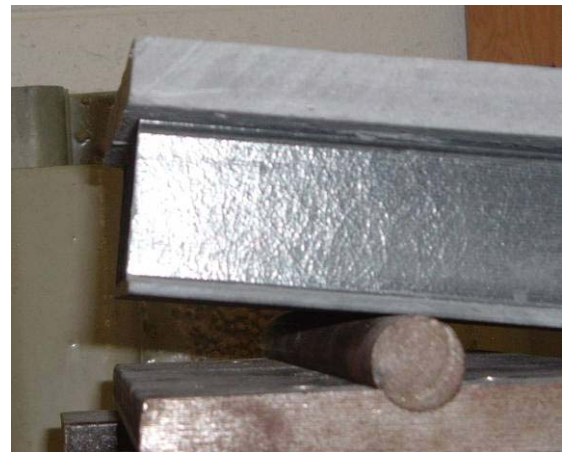
Figure – 13. Slip witnessed during gradual failure of mechanical fasteners (Specimen 2).

Specimen 2 was designed to fail at the interface between the cement board and the FRP plank as previously mentioned. Failure of this specimen began at a load of 3,500 lb. Failure of the mechanical fasteners could be heard as popping sounds occurred with the failure of each individual screw. As failure occurred, slip of the cement board from the FRP plank could be observed (Figure 13). A gradual failure occurred over the final 0.5 inch of deflection with popping sounds heard frequently. The test was finally stopped at a load of 3,820 lb when the largest load drop of about 100 lb was seen as the failure of the screws continued. This equates to a normalized load of 2,864 lb/ft width. At this point, the deflection had reached a maximum of 2.67 inches. The strain data in Figure 14 shows that the cement board did not reach the failure strain of about 0.003.

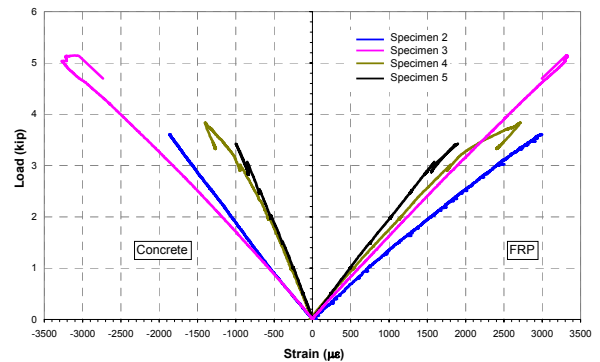
Figure – 14. Strain data for specimens.

Specimen 3 was designed specifically to fail due to crushing of the cement board material. Failure was much more sudden in this mechanically fastened specimen. Where Specimen 2 had slight load drops with each fastener failure, Specimen 3 had a sudden load drop at 5,120 lb where the cement board crushed, which equates to a normalized load of 3,838 lb/ft width (Figure 15). Deflection was significantly less in this mechanically fastened specimen with a final failure deflection of 1.51 inches. No popping sounds were heard throughout the test which indicates the fasteners on the interface did not reach their failure loads. Figure 14

shows that the cement board exceeded the typical failure strain of 0.003.

Both normal concrete specimens failed as a shear debonding failure directly above one or more of the flanges of the FRP plank. Specimen 4 failed gradually over the last 20% of the total deflection. The failure began at a load of about 3,500 lb and the ultimate failure load was 3,800 lb with about 1.01 inches of deflection. The load equates to a normalized load of 2,849 lb/ft width. A debonding failure occurred over all four flanges at the south end of the specimen (Figure 16). No debonding could be seen at the north end of the specimen. Strain data indicates the concrete was not near the 0.003 failure strain (Figure 14).

Specimen 5 experienced a debonding failure that occurred in a much more sudden fashion. The specimen reached a deflection of about 0.73 inches and a load of 3,410 lb before a sudden load drop of 600 lb occurred. This equates to a normalized load of 2,555 lb/ft width. In this specimen, the debonding failure could only be seen over one flange on the south end of the specimen (Figure 17). Again, no debonding failures could be seen on the north end of the specimen. In addition to the debonding cracks in the concrete, tensile cracks could be seen in the concrete under the load line. The tension cracks penetrated about half the thickness of the concrete starting from the bottom and moving upwards. Strain data indicates the concrete was not near the 0.003 failure strain (Figure 14).

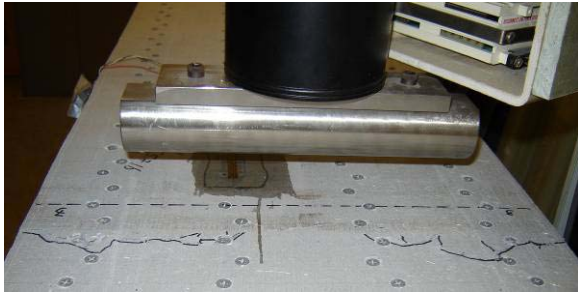
Figure – 15. Cement board crushing observed in second mechanical fastener test (Specimen 3).

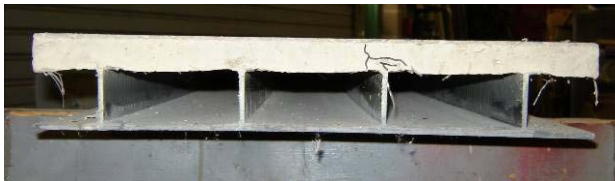
Figure – 17. Debonding failure observed over web 2 of second concrete specimen (Specimen 5).

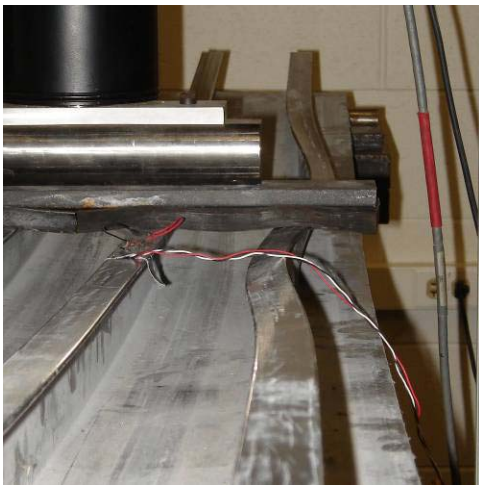
Figure – 18. Buckling failure in FRP plank with Ts up (Specimen 6).

The next two tests were performed to test the performance of the FRP plank alone. The FRP plank is designed to be used with the Ts down, but since the specimens in this research use the FRP with the Ts up, tests were performed with the FRP in both orientations. Specimen 6, Ts up, produced a buckling failure in flange 1 at a load of 2,010 lb and a deflection of 2.09 inches (Figure 18). This load equates to a normalized load of 1,506 lb/ft width. Specimen 7, Ts down, produced a tensile failure in the FRP in flange 2. Before failure, the FRP plank was able to reach a load of 3,950 lb with a deflection of 4.27 inches (Figure 19). The load equates to a normalized load of 2,959 lb/ft width.

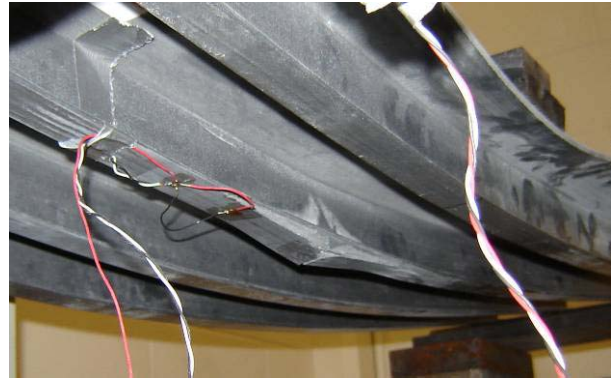
Figure – 19. Tensile failure in flange 2 in FRP plank specimen with Ts down (Specimen 7).

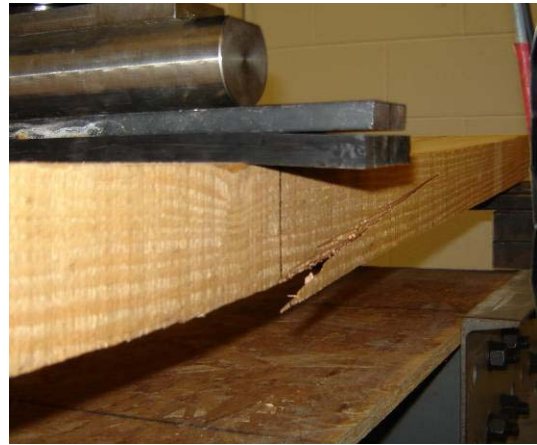
Figure – 20. Bending tension failure seen in timber (Specimen 8).

The final test performed was on the timber specimen (Specimen 8). This specimen was tested with the intent of providing information for comparison to the decking currently used in design. The timber specimen failed by a bending tension crack which occurred below the load point on the west edge of the specimen (Figure 20). The maximum load held by the timber specimen was 4,740 lb at a deflection of 1.54 inches. This equates to a normalized load of 5,030 lb/ft width.

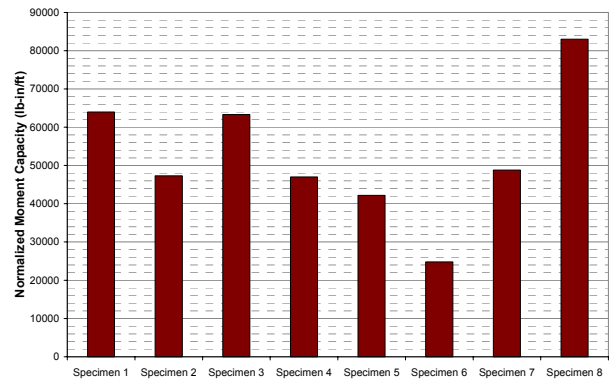
Figure – 21. Specimen moment capacities.

reached by each specimen. Looking at Figure 21, it is evident that the timber specimen has the greatest moment capacity of all specimens. Specimen 1 and Specimen 3 have large load capacities because they have the best bond at the shear interface producing close to fully composite action between the two materials. Specimen 3 failed by cement board crushing indicating the shear bond was maintained throughout the test and specimen 1 failed by debonding at a point close to cement board crushing. Specimen 2 experienced significant slip at the shear bond interface allowing this specimen to achieve a maximum moment only 57% that of the timber. Specimen 2 reached 75% of the load of Specimen 3. Both specimens used mechanical fasteners at the shear bond interface, but Specimen 3 was designed to fail via cement board crushing. This information could be useful in designing an efficient mechanical fastener specimen which can achieve an efficient stiffness and load carrying capacity. The concrete specimens have maximum moments about 54% that of the timber, but still have the ability to hold a wheel load of 1,000 lb with a safety factor of over 2.5. The FRP specimens produced significantly different results due to stability factors. Specimen 6 was arranged with the Ts up allowing buckling to be a factor in the load carrying capacity. Specimen 6 was only able to reach a load about 50% of Specimen 7. Specimen 7 reached a moment capacity comparable to the two concrete specimens.

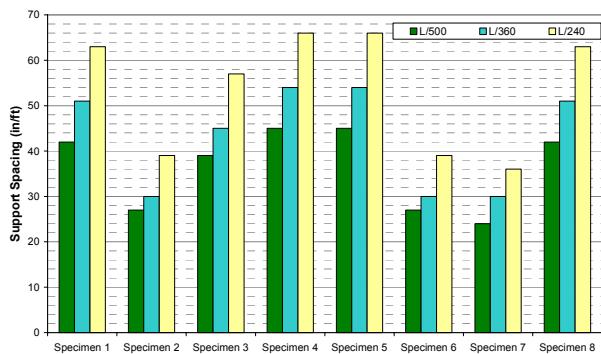
**Figure – 22. Maximum support widths for 1,000 lb wheel load based on deflection limits.**

Using the slope of the load versus deflection curves, the effective stiffness of the different specimens can be compared (Figure 22). This stiffness can be used for design purpose to ensure deflection limits are not exceeded when designing the deck of the bridge. To find the effective stiffness, the slopes of the different load versus deflection curves were used in the equation

Table 3 shows the effective stiffness of each of the specimens. Once the effective stiffness of each specimen had been determined, comparisons of deflection criteria could be made. As seen in Figure 22, supporting beam or truss spacing for the decking was computed based on deflection limits and the effective stiffness of each specimen as calculated based on the normalized test data. The largest support spacing can be achieved using the

normal weight concrete with the FRP plank. On average, it was found that the normal weight concrete with the FRP plank could achieve support spacing about 6% wider than timber. Both normal concrete tests provided similar results with respect to the effective stiffness of the two specimens. The epoxy-bonded cement board was found to allow about the same support spacing as the timber. The two mechanically fastened specimens produced very different results. The mechanically fastened specimen designed to fail via the fasteners at the shear interface yielded support widths only 62% of timber. On the other hand, the mechanically fastened specimen designed to fail via cement board crushing yielded support widths 91% of timber. Neither mechanically fastened specimen was able to achieve an effective stiffness similar to that of timber. The effective stiffness of both FRP plank specimens was found to be significantly smaller than the timber. Both specimens could achieve support widths only about 60% of what timber is capable of spanning based on deflection limits.
